GLASS OR CERAMIC SPHERICAL-SHELL  
WINDOW ASSEMBLY FOR 20,000-PSI  
OPERATIONAL PRESSURE

Jerry D. Stachiw

Naval Undersea Center  
San Diego, California

May 1974

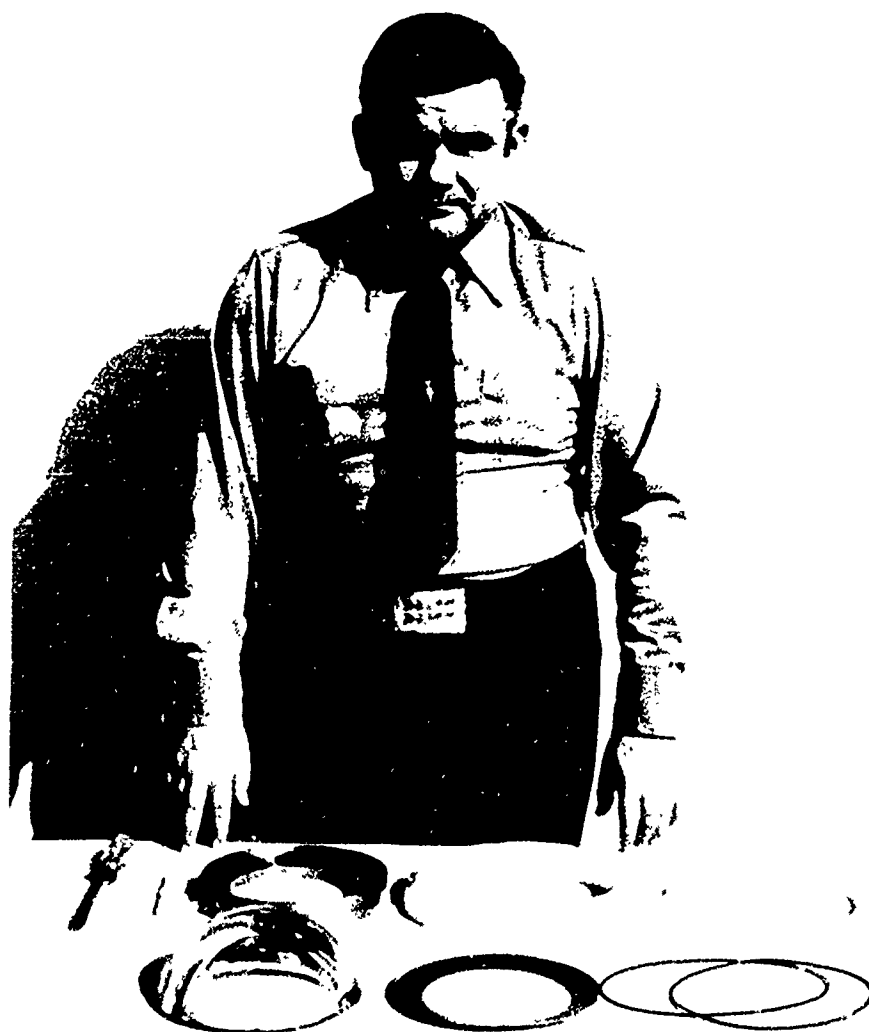
Figure A.1. Components of the window-flange subsystem.
